# How to Check and Fix When Pumpkin Car Stereo Head Unit Not Turn on

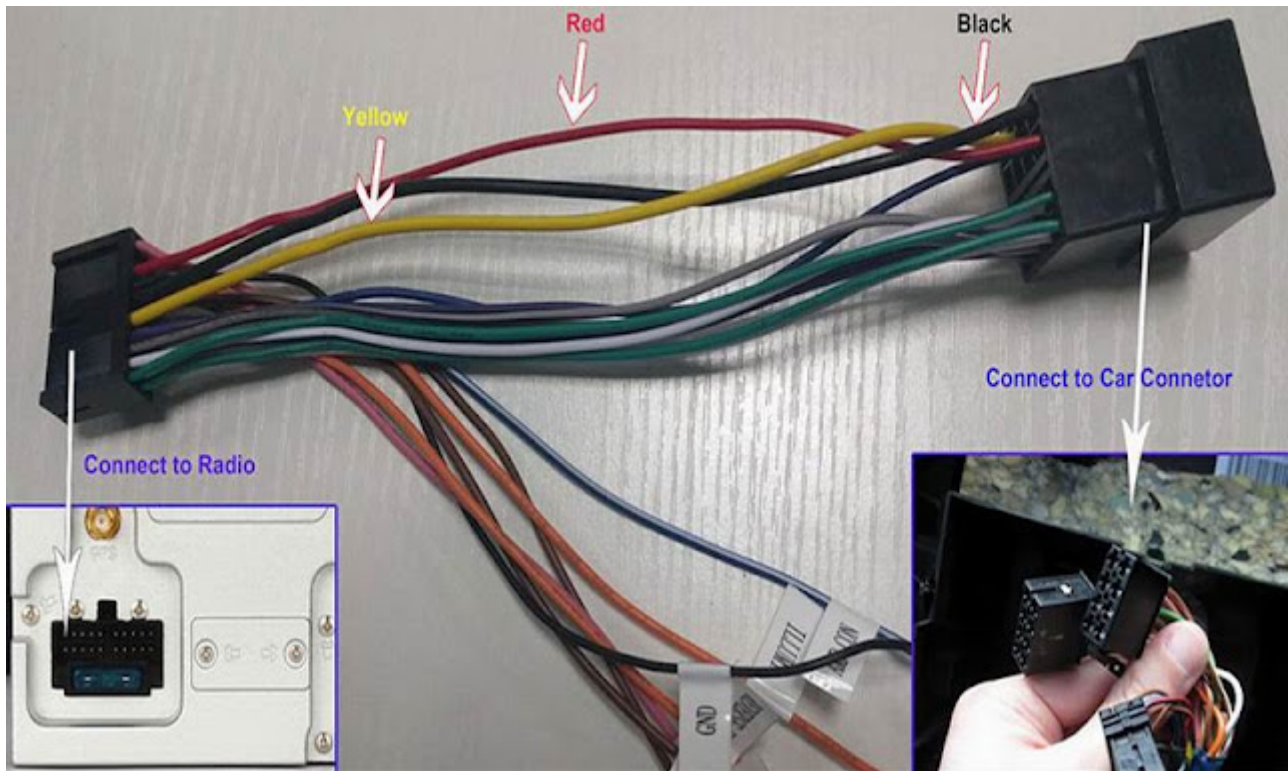
For the [universal car dvd players](#) with ISO power cable. Please first check if your car have the canbus system which control your original radio turning on or off. Your car don't have canbus system, then you just need to make sure you connect the below three wires correctly, then the unit will turn on when start your ignition key.

- Bold Yellow Wire need to connected to your car battery to get 12V permanent power supply
- Red Wire 12V should be connected to your car ignition (ACC) wire
- Bold Black to Ground

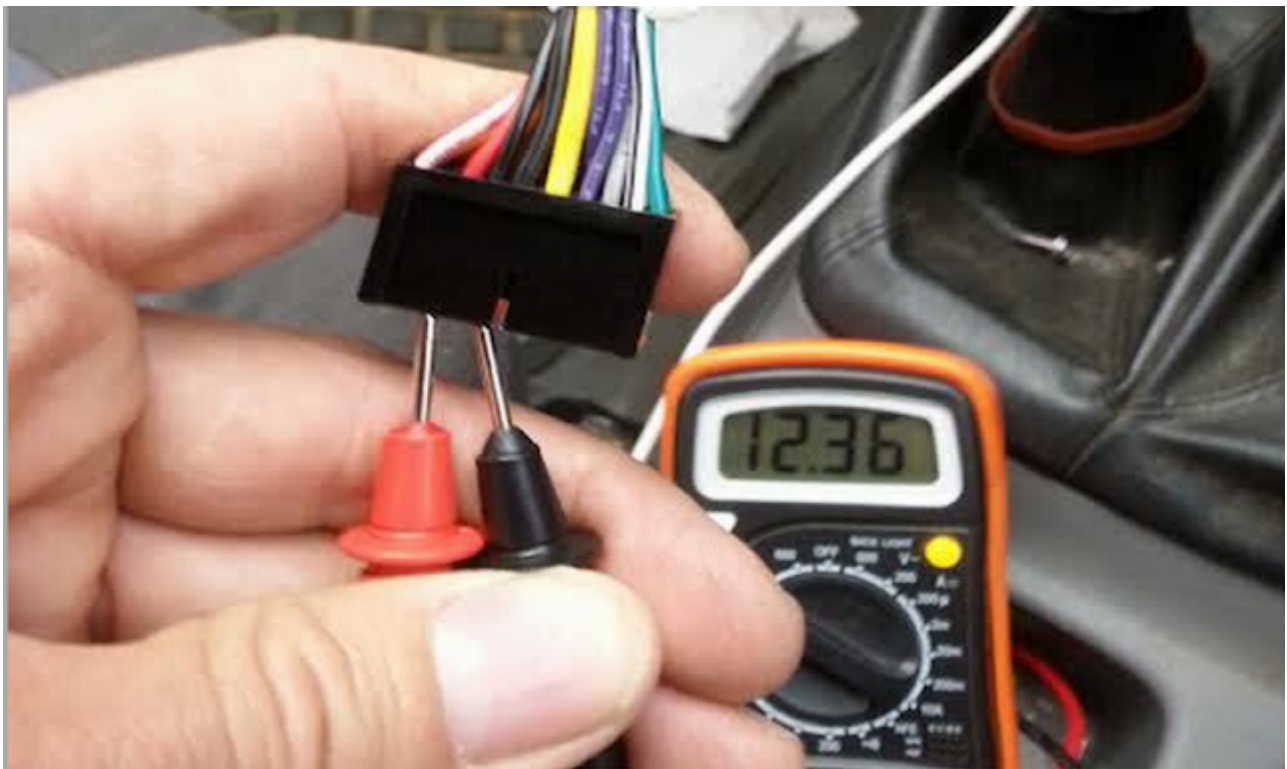
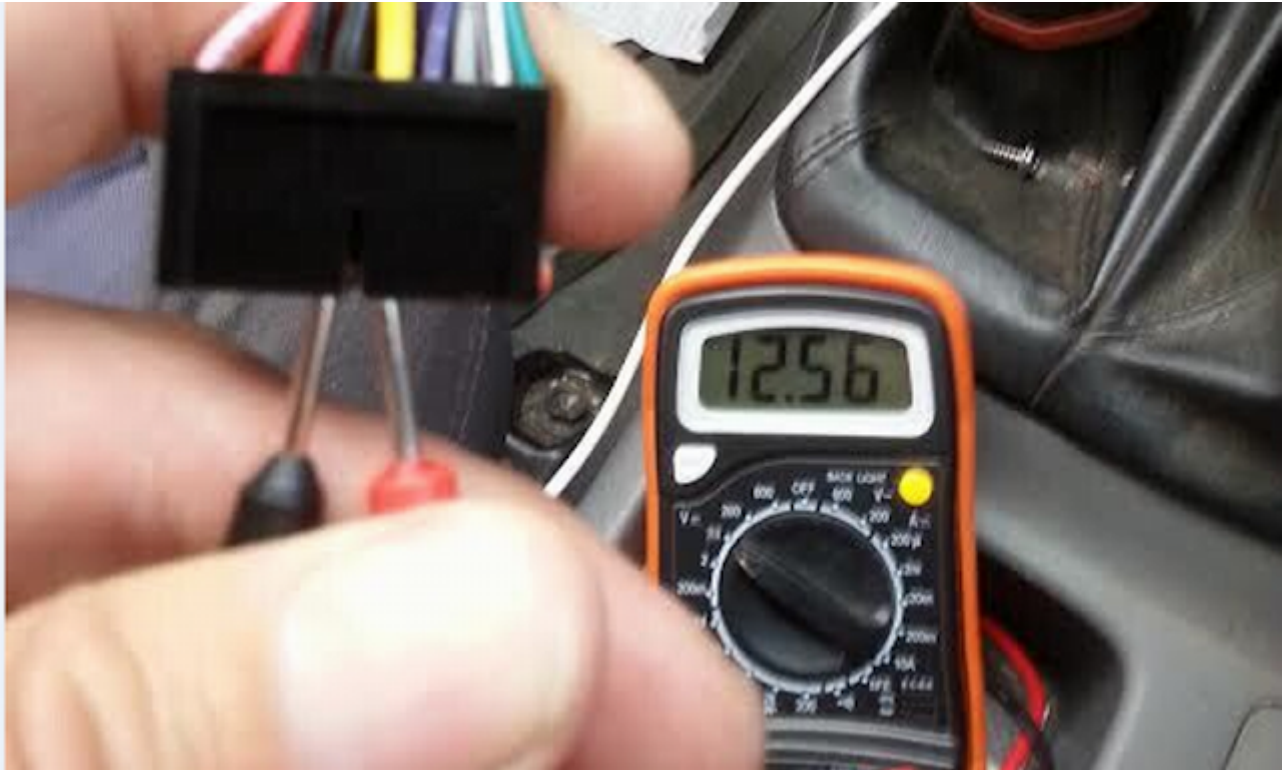
Then check at the power harness both on the radio side and

other Car connector side.

Please make sure power harness on the radio side connected tightly and the blue fuse in the back of our unit.

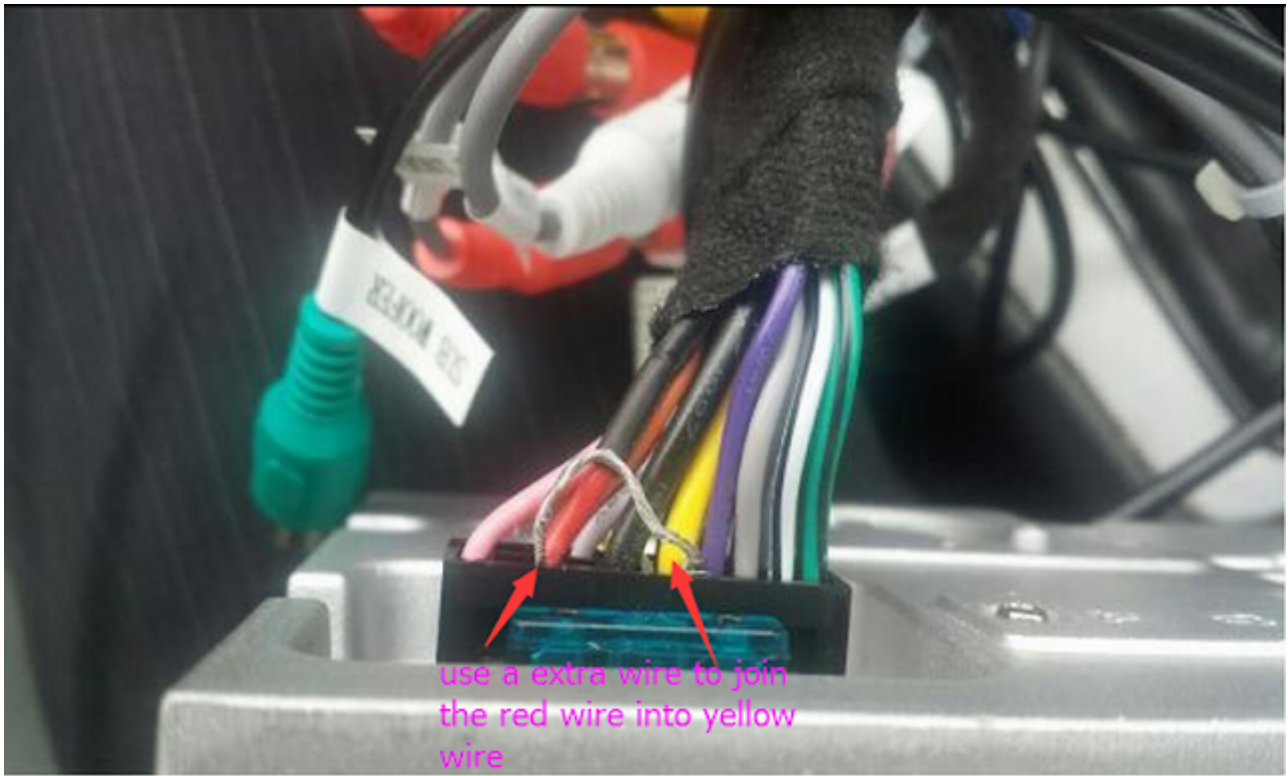
If the canbus box have problem, then our unit can not be turn on normally. Under this situation, you can remove the canbus box, then cut the red wire and join it into bold yellow wire, or refer the below picture using a extra wire to connect the red and yellow wire

If the car stereo can be turned on with this wire modification and your car car don't have steering wheel control or you don't mind the steering wheel control, you can just connect the red wire to your ignition ACC wire, then you can continue to use the unit.

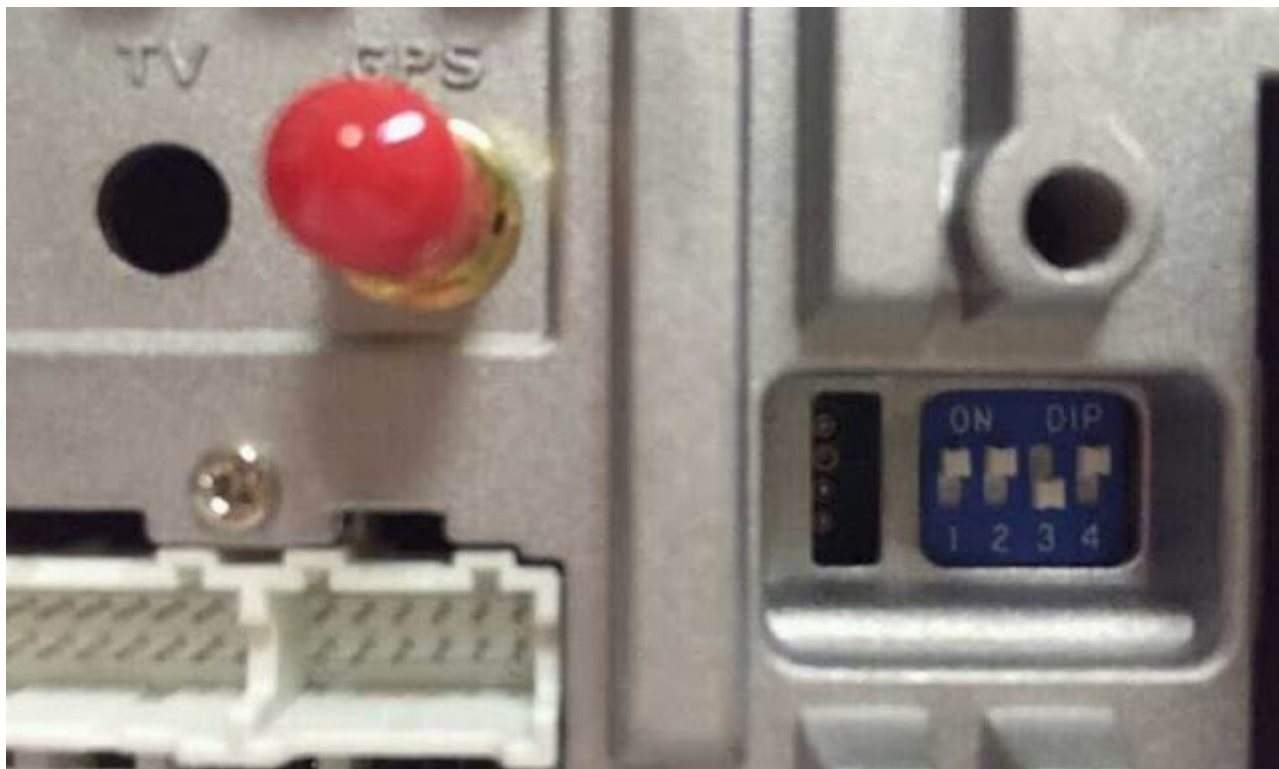
When you get our unit first time and install, please first check if the DIP NO.3 turn down, then just plug your original power cable to our unit.

If you used the unit after some time, suddenly the unit could not be turned on, it's possible the built in canbus have fault.
