How to Check and Fix When Pumpkin Car Stereo Head Unit Not Turn on

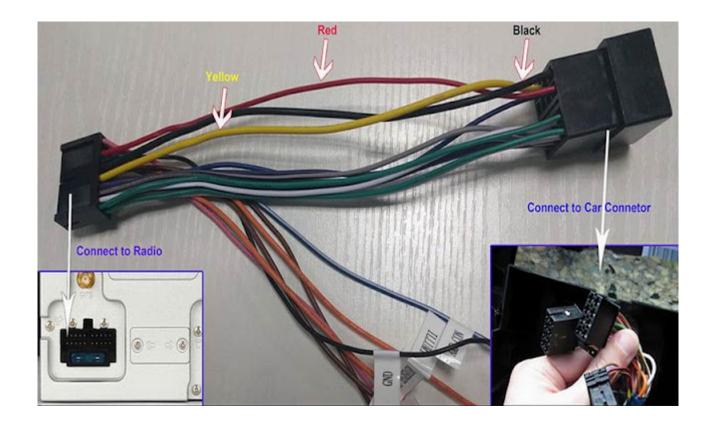
- -Bold Yellow Wire need to connected to your car battery to get 12V permanent power supply
- -Red Wire 12V should be connected to your car ignition (ACC) wire
- -Bold Black to Ground

For the <u>universal car dvd players</u> with ISO power cable. Please first check if your car have the canbus system which control your original radio turning on or off. Your car don't have canbus system, then you just need to make sure you connect the below three wires correctly, then the unit will turn on when start your ignition key.

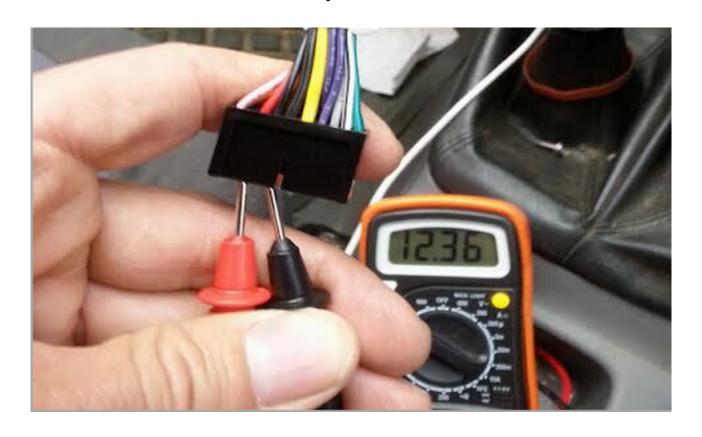
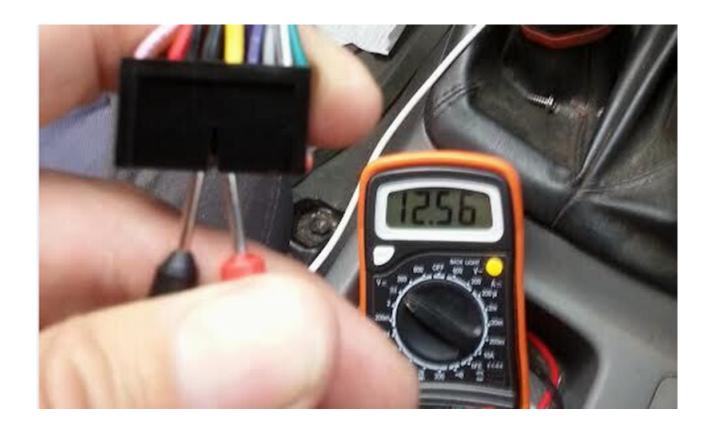
Please make sure power harness on the radio side connected tightly and the blue fuse in the back of our unit.

If you exclude all these possible situation, you may need to remove the unit from your car to test if the red and bold yellow wire have 12V-14 V power suppply.

You can also install your original radio to check if it's the power supply problem or the power cable problem. Here is a tutorial video for your reference.

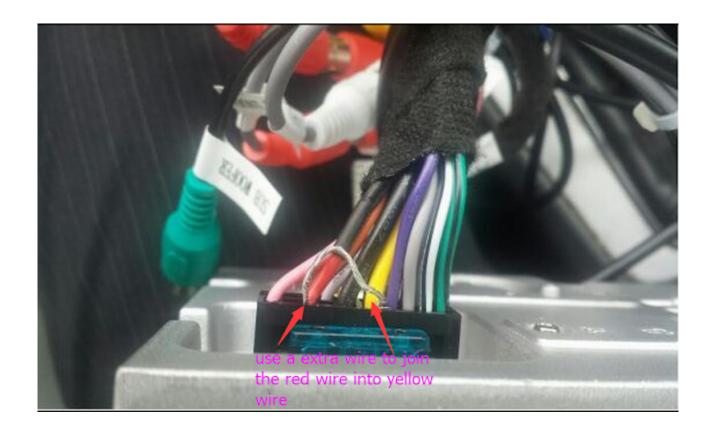
If the canbus box have problem, then our unit can not be turn on normally. Under this situation, you can remove the canbus box, then cut the red wire and join it into bold yellow wire, or refer the below picture using a extra wire to connect the red and yellow wire

If the car stereo can be turned on with this wire modification and your car car don't have steering wheel control or you don't mind the steering wheel control, you can just connect the red wire to your ignition ACC wire, then you can continue to use the unit.

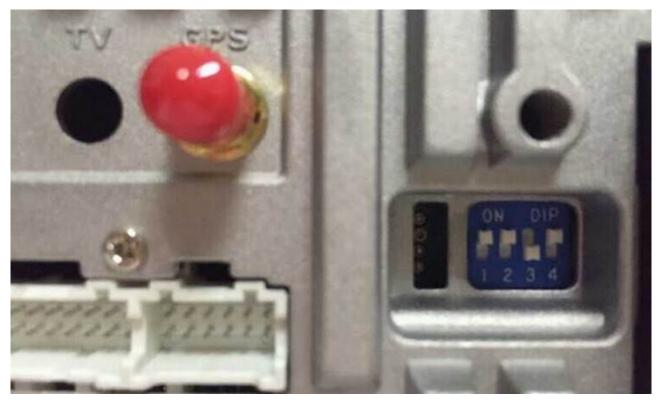
If you used the unit after some time, suddenly the unit could not be turned on, it's possible the built in canbus have fault.

When you get our unit first time and install, please first check if the DIP NO.3 turn down, then just plug your original power cable to our unit.
